LAUREL CREEK DAM

PHASE I INSPECTION REPORT

NATIONAL DAM INSPECTION PROGRAM

Name of Dam: LAUREL CREEK DAM
State & State Number: PENNSYLVANIA - 44-62
County Located: MIFFLIN
Stream: LAUREL CREEK, SUSQUEHANNA
Date of Inspection: May 12, 1978

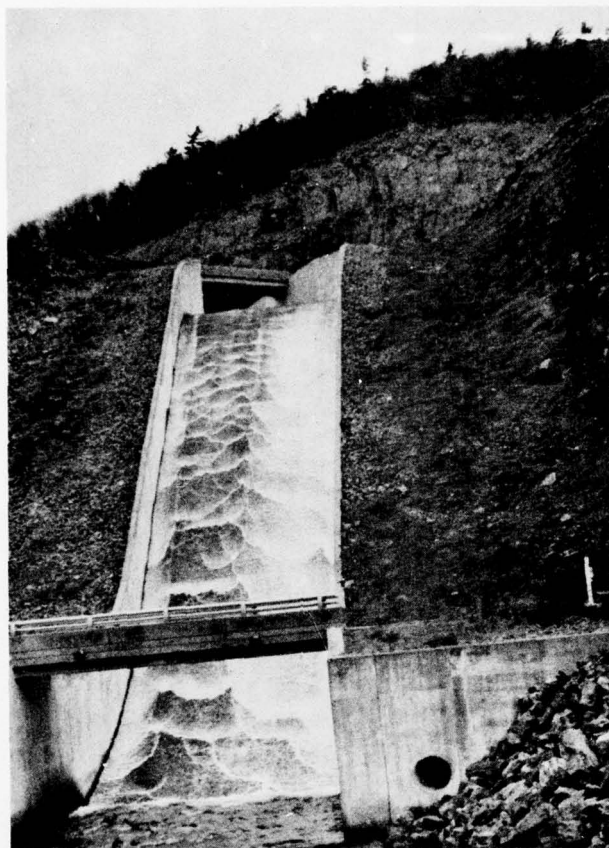
Spillway

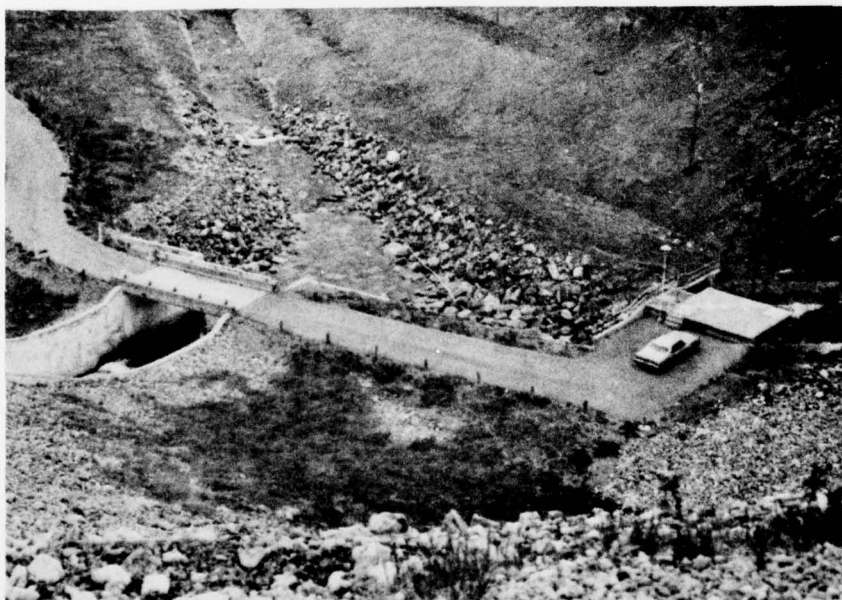
The downstream channel below the deflector bucket is well defined. The slopes are stable and protected with riprap. The creek flows past the treatment plant and under Route 322 through a large culvert. The Borough of Milroy is located approximately 2.3 miles downstream from the dam. Many houses and trailers in this community are located close to the stream. A failure of the dam would cause considerable loss of life and property and therefore, this dam is considered to be in the "High" Hazard Classification.

Downstream
Channel

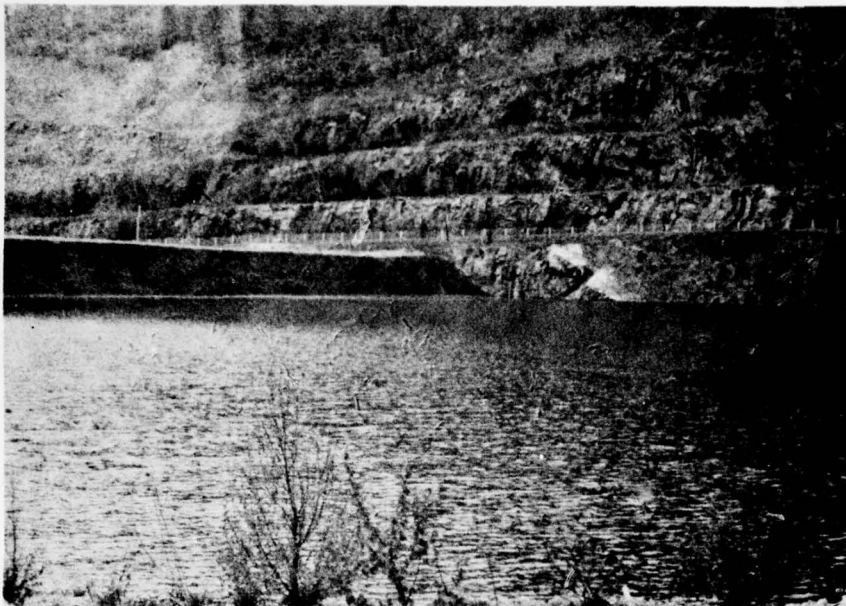
Upstream Slope
Right Abutment

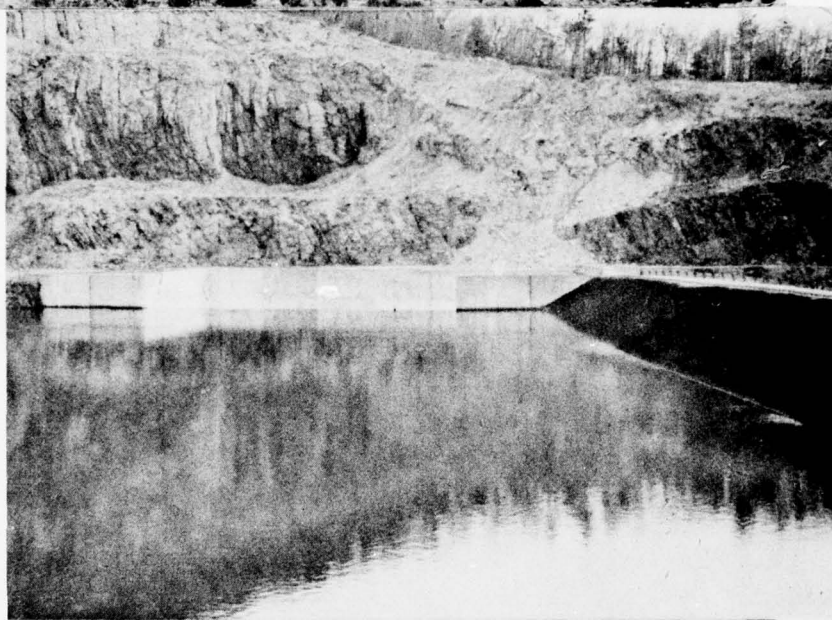
Upstream
Left Abutment

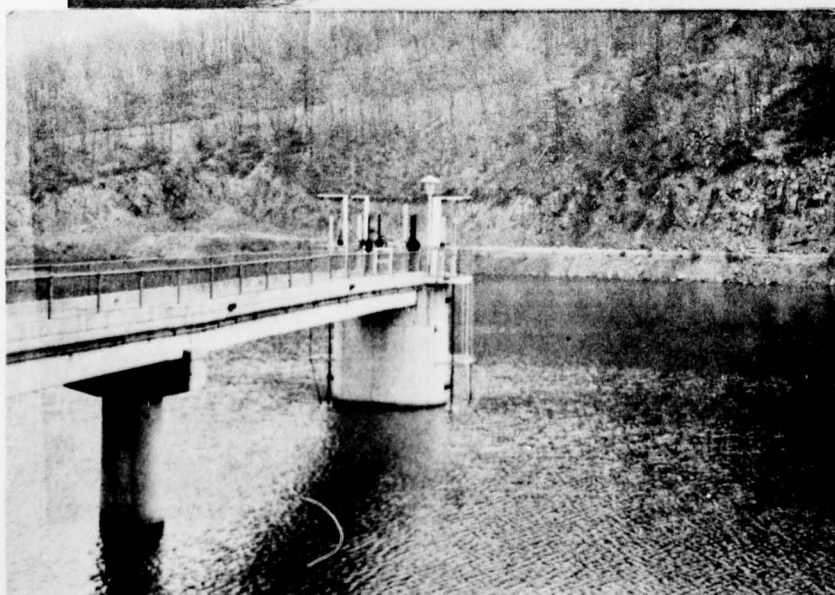
The treatment plant operator stated that the gates and valves on the intake tower are operated regularly (2 to 3 times a year), except the low drawdown gate, which has not been operated since 1972. Ice damage to the stem of the highest intake prevents operation of this gate until repairs are made.

Control Tower

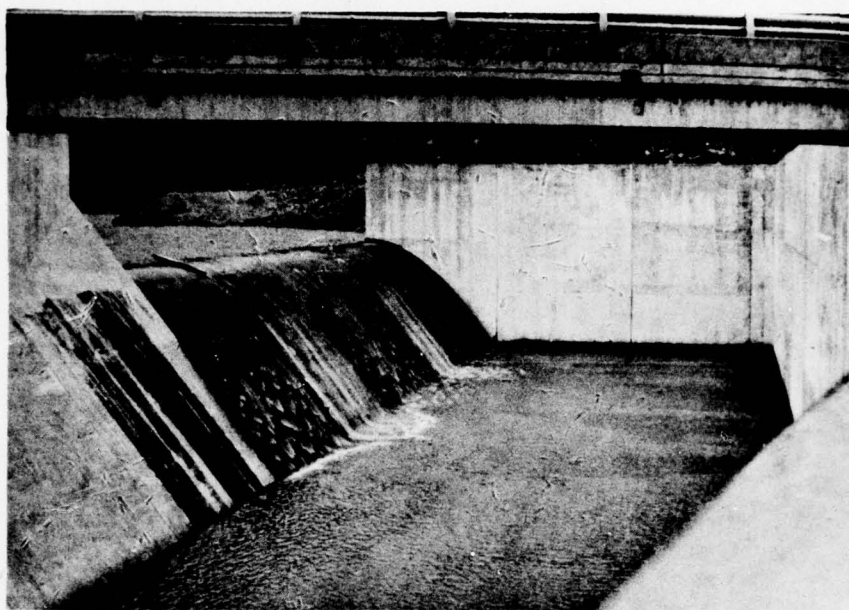
Spillway
Weir

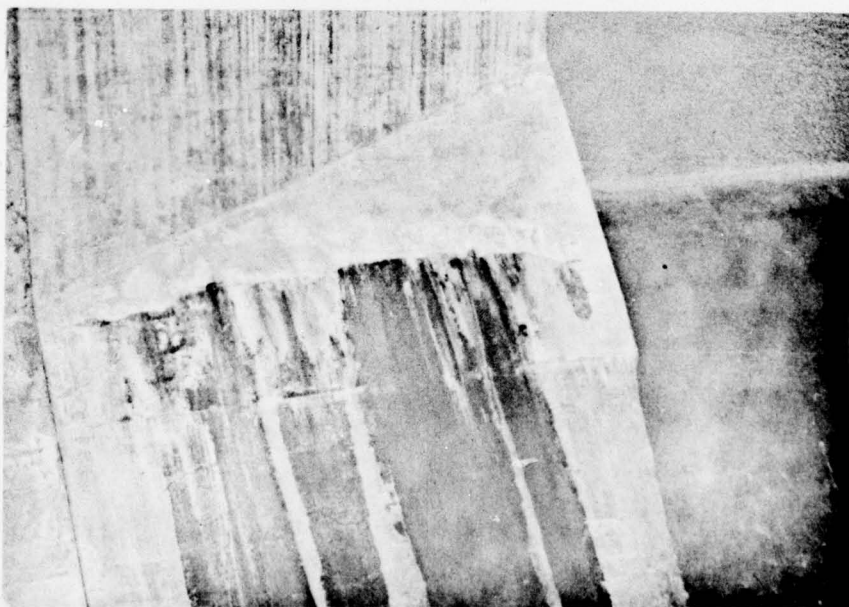
PLATE V

All appurtenant structures were in good condition. Besides some shrinkage cracking, a crack was noticed near the entrance of the spillway (Appendix D, Plate V). The manager stated that this crack will be pressure grouted during the summer (1978), when the pool level falls 3 or 4 feet below spillway crest. The cause of the crack could not be determined. Water over the spillway has not been high enough to cause any stresses in this wall. It could have been a cold joint with poor workmanship after the pour started.

Indications are from representative of owner that when the reservoir gets below spillway level and the crack level repairs are going to be made. (7' to 8' normal drop below spillway during summer) has been as much as 14' below.

Cracked Wall
At Spillway

1. The owner should install an outside staff gage on the control tower.
2. The owner should repair the crack in the wall near the spillway.
